STATEMENT REGARDING HISTORICAL SIGNIFICANCE of the LESTER HAYDEN HOUSE

FORM B - BUILDING

Address: 1 Mt. Gilboa Road

Historic Name: Lester Hayden House and Garage

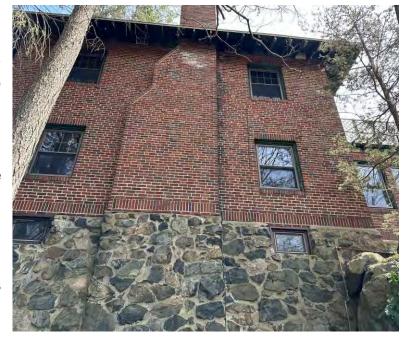
In addition to the loosened stonework, there are what appear to be structural cracks running into the stonework. These occur at the following locations:

Diagonally downward and

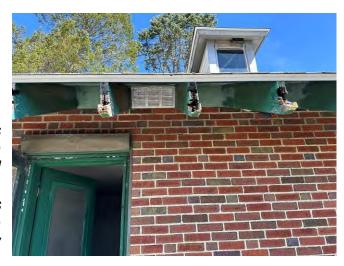
The gutters and fascia boards have been removed or have fallen off nearly all of the roof eaves, leaving the angled tails of the rafters exposed and, unfortunately, in many places rotting. This has occurred at at least the north and south elevations. The rafter ends should be cut off and replaced with matching extensions that are plywood gusseted to remaining sound material, at least the fascia, if not the gutter as well, should be reinstalled to provide proper water protection to the new rafter ends.

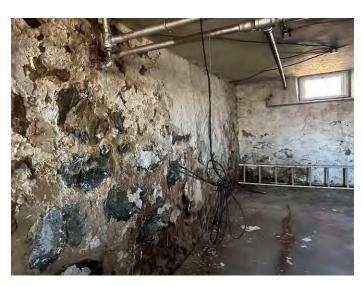
- There was a small wet area on the floor near the southwestern-most column. This may be from water either seeping through the wall or through the floor and should be investigated. The sump pit was not overtopped at the time of my visit, so floor seepage seems unlikely.
- There are several wood-framed partitions in the basement. The wall between the stairway and the south portion of the basement is uneven and bowing to one side.
- There are numerous cracks in the surface parging on the west foundation wall. This is consistent with the deterioration noted on the outside. The cracks should be pointed and/or grouted and reparged.
- Much of the south wall has peeling paint and missing parging, exposing the mortar joints and bare stonework beneath. This wall is nested into the sloping grade behind it and appears to be a significant avenue for water to seep into the basement from the

exterior grade. The stonework should be deeply cut and pointed with a stiff, cement-based mortar and the wall re-parged and painted. An attempt should also be made to catch and channel water from the ground surface above and away from the foundation.

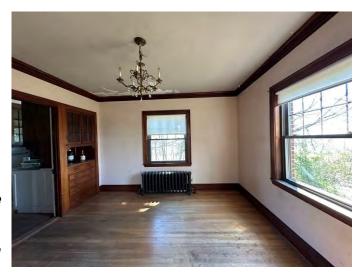
- There is water-related plaster damage on the eastern edge of the presumed dining room's ceiling. The likely source of leakage is the exterior wall or second floor window, above, and should be investigated and corrected.
